AirQuest Project #20946

Limited Pre-Renovation Report of Building Material Survey, Sampling, and Evaluation of Asbestos Containing Materials

For:
Commercial Buildings
204, 220, and 230 North Krome Avenue
Homestead, Miami-Dade County, Florida 33030

October 18, 2024

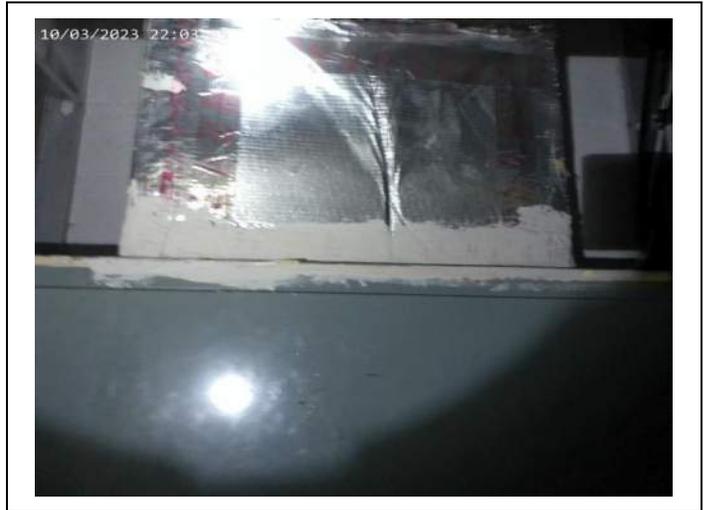
4. HA 1: White HVAC Mastic

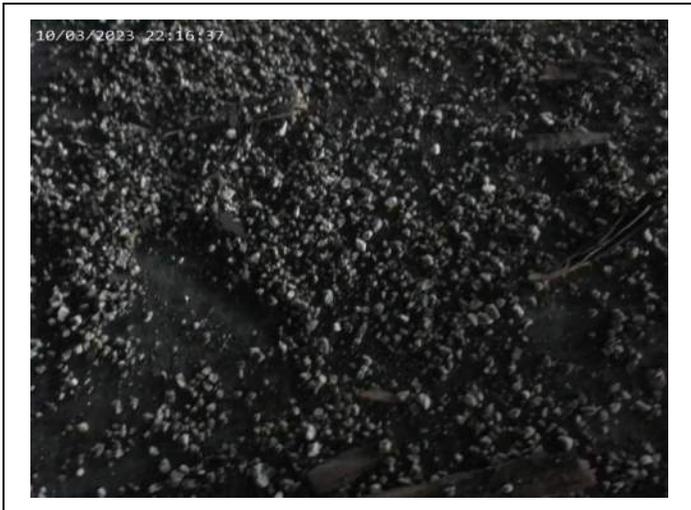
7. HA 4: Tar & Gravel Roof

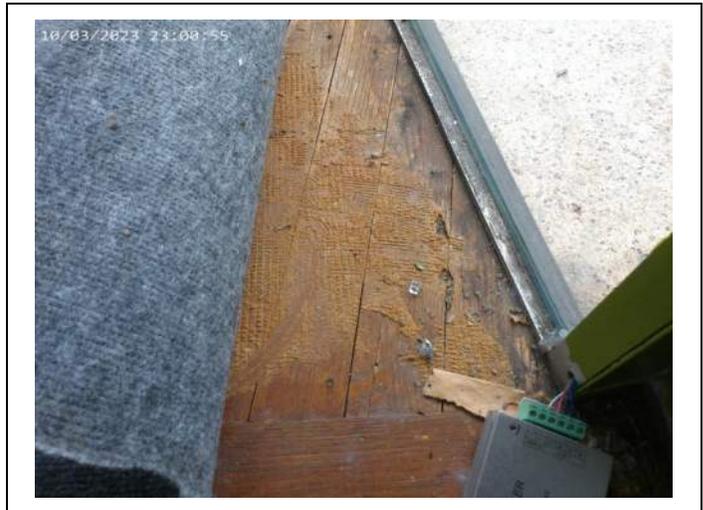
20. HA 12: Yellow Mastic under Gray Carpet

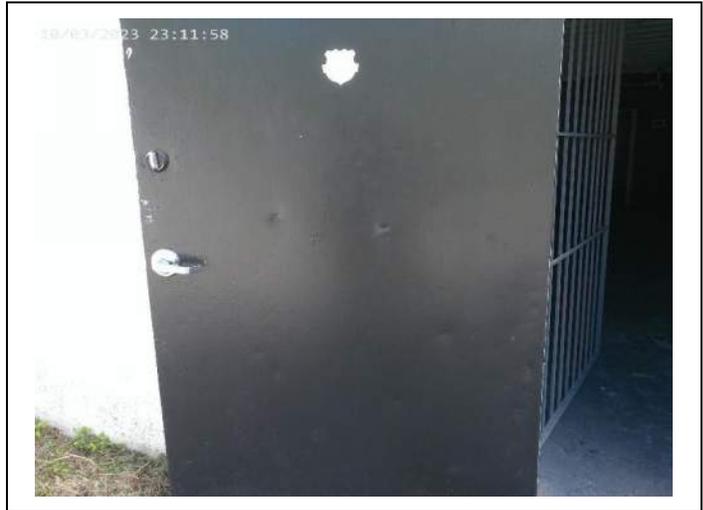
28. HA 21: Rear Entry Fire Door

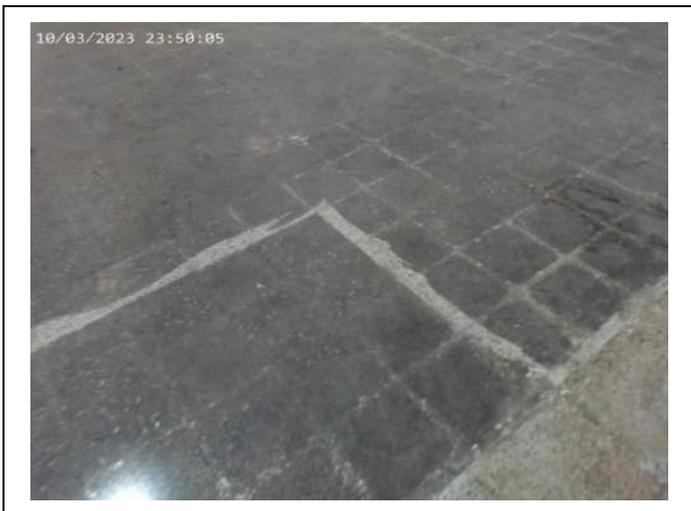
35. HA 24: 9" x 9" Gray, Vinyl Floor Tile and Associated Black Mastic

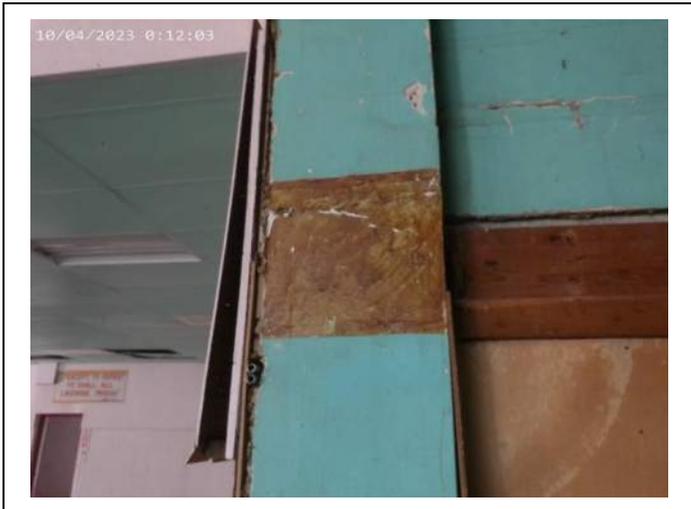
39. HA 28: Yellow Mastic near Ceiling

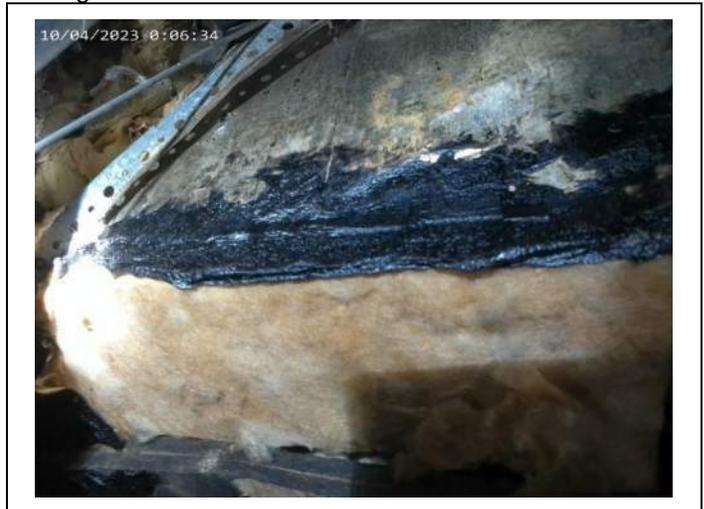
Homogenous Area (HA) Material	HA Location	Percentage/ Type	Material Condition/ Friability	Approximate Quantity	Category
HA 29: Black HVAC Mastic	Space 204: Above Showroom Drop Ceiling	10% Chrysotile	Damaged / Non-Friable	200 LF	Category I NESHAPs
HA 36: Fire Door Insulation	Space 204: Rear Door	NOT TESTED - ASSUMED POSITIVE	Good / Friable	1 Each	RACM
SF- Square Feet LF- Linear Feet NAD- No Asbestos Detected NESHAP- National Emission Standards for Hazardous Air Pollutants Friable- Material that may be crumbled, pulverized, or reduced to powder by hand pressure when dry. Non-Friable- Material that, when dry, may not be crumbled, pulverized, or reduced to powder by hand pressure. RACM- Regulated Asbestos Containing Material

40. HA 29: Black HVAC Mastic

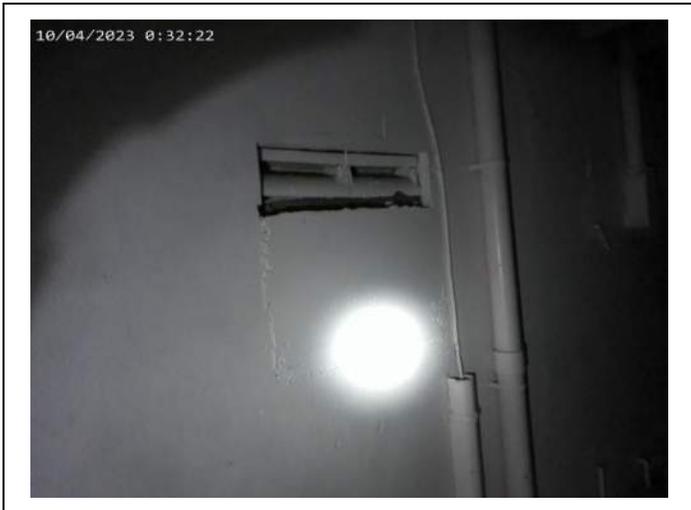
43. HA 32: Transite-Like Vent

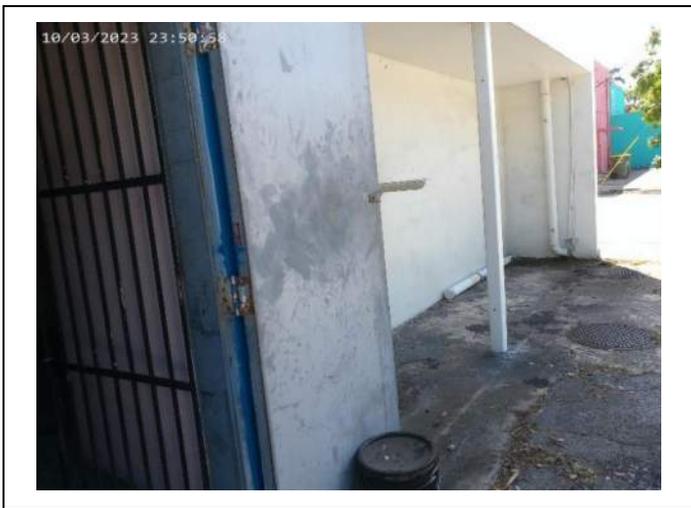
HA 36: Fire Door Insulation	Space 204: Rear Door	NOT TESTED - ASSUMED POSITIVE	Good / Friable	1 Each	RACM

47. HA 36: Rear Entry Fire Door

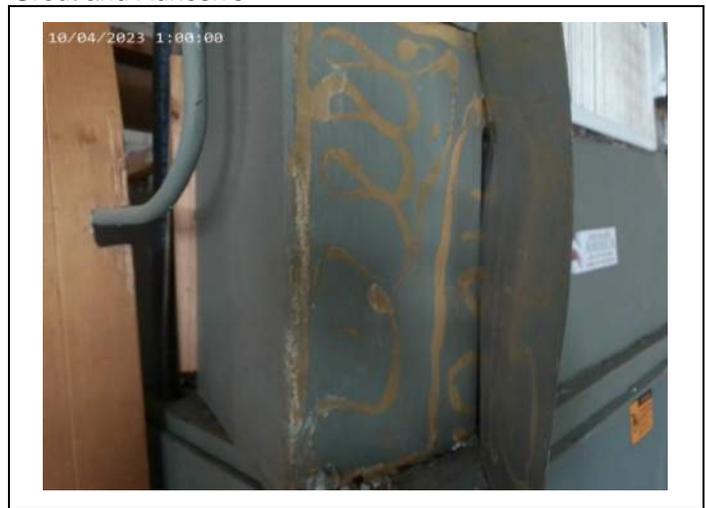
48. HA 37: Yellow Mastic on Heater
